Flexco® 190 MegAlloy® Fasteners Repair Rip at Midwest Aggregates Plant

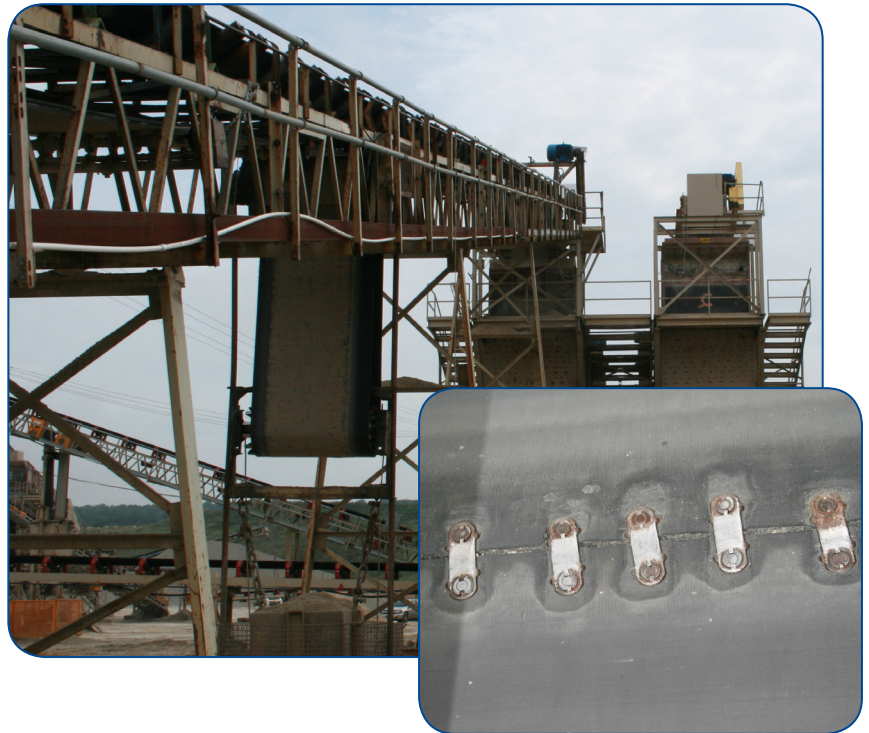
A major rock quarrying operation in the Midwest experienced a work-stoppage after a plate of steel fell out of a receiving hopper and jammed into the corner of the conveyor. Before the crew could react, the sharp triangle tip ripped the incline belt. The year-old belt had been in good condition until the 104 m (340-foot) rip caused it to stop, bringing activity to a halt in the plant. Replacing the new belt would take too much time and was not in the quarry's budget. Since the 1219 mm (48") belt had already lost 457 mm (18") of width, the only solution was a mechanical fastener rip repair.

Flexco® 190 MegAlloy fasteners were ordered to stitch the middle of the belt together. First, workers cut out 457 mm (18") of belt to ensure that the belt they were working with was fresh belt with no possibility for additional rips. Several workers then pulled the belts side-by-side and placed the 190 fasteners approximately 76-101 mm (3-4 inches) apart for the entire length of the belt. More than 1200 Flexco fasteners were used when repairing the belt. The repair team used 13 mm (1/2") square drive impact tools, HW1 wrenches, HP1 punches, and 110 bolt breaker tools to speed installation of the fasteners.

The entire repair job was completed in only three days by a crew that was on hand, avoiding further downtime. While the belt width is slightly narrower, the operation is back up and running, carrying stone up the incline to the scalping screen. The choice of MegAlloy fasteners is beneficial to the quarry as the hardened steel is highly resistant to wear and abrasion, making it perfect for an aggregate application. The quarry also saved an average of \$35-\$40 per foot, approximately \$12,000, by repairing the rip with fasteners as opposed to purchasing new conveyor belting.
