## Application Profile

# Flexco® 190 MegAlloy® Fasteners Repair Rip at Midwest Aggregates Plant

Incline belt leading to scalping screen

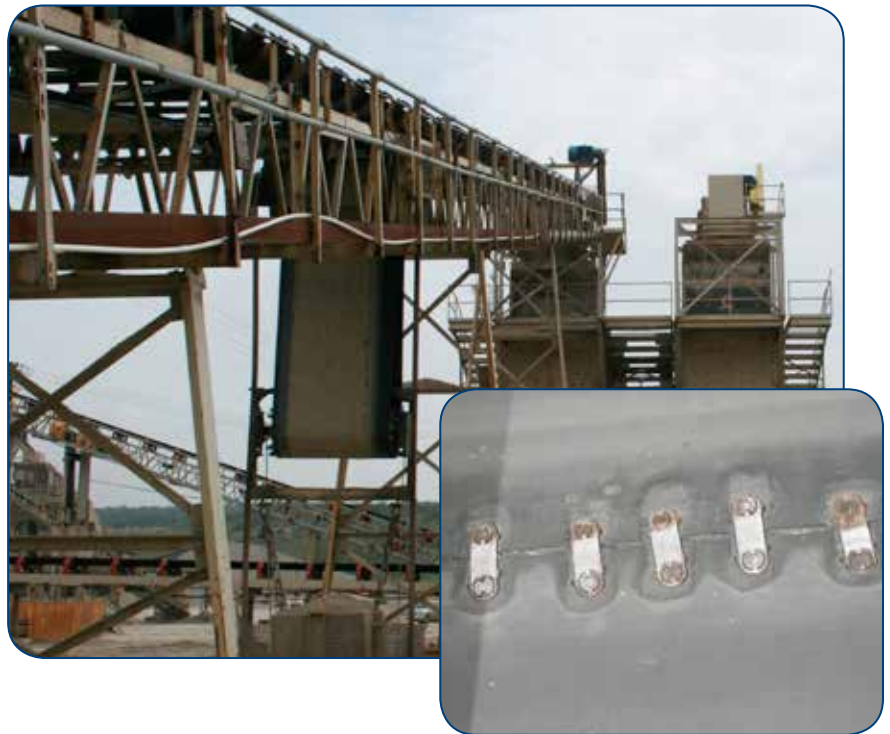
A major rock quarrying operation in the Midwest experienced a work-stoppage after a plate of steel fell out of a receiving hopper and jammed into the corner of the conveyor. Before the crew could react, the sharp triangle tip ripped the incline belt. The year-old belt had been in good condition until the 340-foot rip caused it to stop, bringing activity to a halt in the plant. Replacing the new belt would take too much time and was not in the quarry's budget. Since the 48" belt had already lost 18" of width, the only solution was a mechanical fastener rip repair.

Flexco® 190 MegAlloy fasteners were ordered to stitch the middle of the belt together. First, workers cut out 18" of belt to ensure that the belt they were working with was fresh belt with no possibility for additional rips. Several workers then pulled the belts side-by-side and placed the 190 fasteners approximately 3-4 inches apart for the entire length of the belt. More than 1200 Flexco fasteners were used when repairing the belt. The repair team used 1/2" square drive impact tools, HW1 wrenches, HP1 punches, and 110 bolt breaker tools to speed installation of the fasteners.
