Road Builder Keeps Paving Machinery on Schedule with Conveyor-Belt Rip Repair Plates

Concrete placer conveyor

Flexco® Bolt Solid Rip Repair Fastener

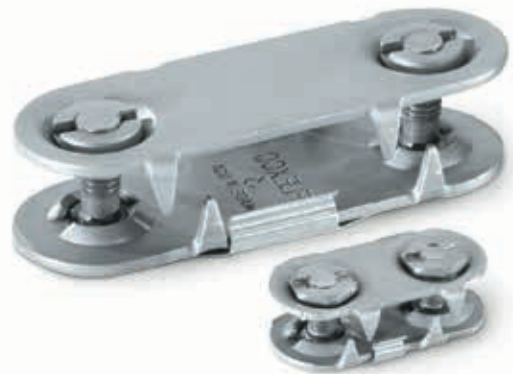
The concrete placing machine receives fresh concrete from a continual parade of ready-mix trucks and lays down a 7.3 m (24')-wide, 280 mm (11")-thick blanket for finishing by the paving machine close behind. While racing the calendar to finish widening a 16 km (10-mile) stretch of Interstate highway ahead of the winter snow, the placer was disabled by a piece of scrap iron that slashed the belt nearly through. Two cuts, 6 m (20') and 3 m (10') long, extended for nearly 60% of the belt length. The belt would not last long under the weight of fresh concrete. Having a "saddle" of new belting vulcanized would cost several thousand dollars. A totally new belt would cost even more and add up to a 10-day delay.

Flexco® #140 Rip Repair Plates sutured the wounds, with 36 plates spaced at 254 mm (10") intervals. First, bolt-holes were punched with a special boring tool and locating templet. Then, to avoid interfering with the tight scrapers needed to remove wet concrete carryback, each plate's 64 x 25 mm (2-1/2" x 1") shape was mortised out of the

belt's top cover with a router to a depth of about 4.8 mm (3/16") so the top plates would nest flush with the surface. Finally, top and bottom plates were drawn tightly into the belt with two heat-treated bolts, while short teeth formed into the plate edges near the bolts increased each plate's grip. These special bolts, inserted upwards from the underside of the belt, have flat heads that seat into pockets formed in the bottom plates to assure smooth passage across drive pulleys and idlers.
