Road Builder Keeps Paving Machinery on Schedule with Conveyor-Belt Rip Repair Plates

Concrete placer conveyor

Flexco® Bolt Solid Rip Repair Fastener

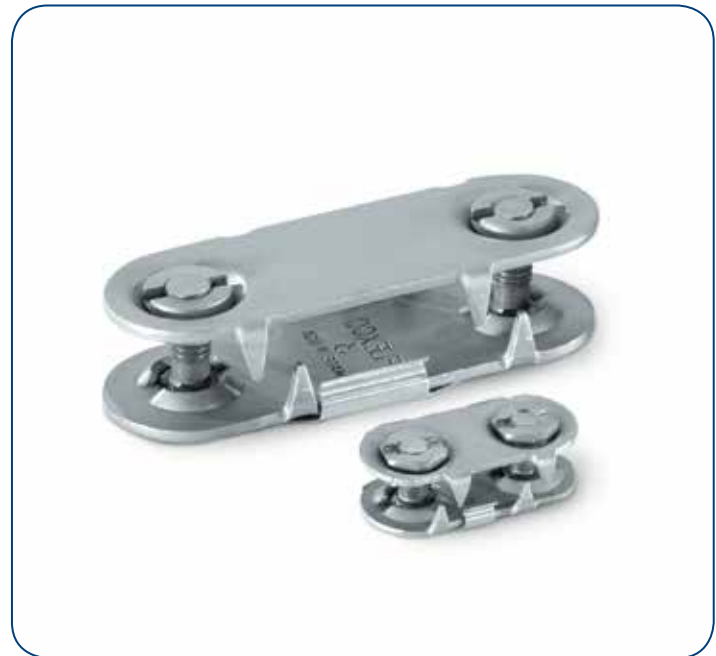
The concrete placing machine receives fresh concrete from a continual parade of ready-mix trucks and lays down a 24' (7.3 m)-wide, 11" (280 mm)-thick blanket for finishing by the paving machine close behind. While racing the calendar to finish widening a 10-mile (16 km) stretch of Interstate highway ahead of the winter snow, the placer was disabled by a piece of scrap iron that slashed the belt nearly through. Two cuts, 20' and 10' long, extended for nearly 60% of the belt length. The belt would not last long under the weight of fresh concrete. Having a "saddle" of new belting vulcanized would cost several thousand dollars. A totally new belt would cost even more and add up to a 10-day delay.

Flexco® #140 Rip Repair Plates sutured the wounds, with 36 plates spaced at 10" (254 mm) intervals. First, bolt-holes were punched with a special boring tool and locating templet. Then, to avoid interfering with the tight scrapers needed to remove wet concrete carryback, each plate's

2-1/2" x 1" (64 x 25 mm) shape was mortised out of the belt's top cover with a router to a depth of about 3/16" (4.8 mm) so the top plates would nest flush with the surface. Finally, top and bottom plates were drawn tightly into the belt with two heat-treated bolts, while short teeth formed into the plate edges near the bolts increased each plate's grip. These special bolts, inserted upwards from the underside of the belt, have flat heads that seat into pockets formed in the bottom plates to assure smooth passage across drive pulleys and idlers.

The entire repair job was completed in less than eight hours by the regular work crew, avoiding at least a full day of vulcanizing downtime (and probably more), waiting for the vulcanizing contractor's crew to arrive. Total cost, less than \$35 for the Flexco plates, was considerably less than vulcanizing. The rest of the crew simply moved ahead to grade another section of roadbed and relocate machinery, so the overall construction schedule was not disrupted by the relatively brief downtime. With repair plates installed, the placer belt ran through the rest of the season, postponing installation of a new belt until winter finally brought roadwork to a stop.
