Application Profile

Flex-Lag[®] Weld-On[™] Rubber Pulley Lagging saves aggregates operation 50% in installation time and is compatible with cleaners.

Product Flex-Lag[®] Weld-on Rubber Lagging

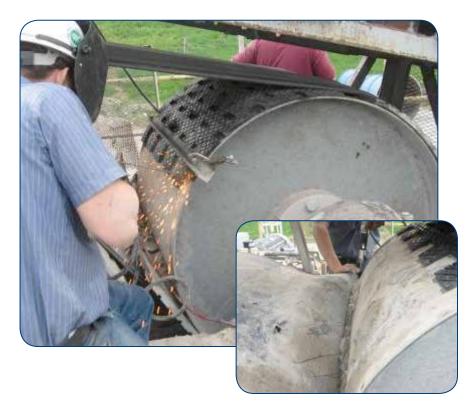
3 ply x 330 belt Lagging installed on head pulley Precleaner on head pulley

The company needed to find a lagging solution that would be compatible with its precleaner. With its patented gear tooth design and ease of installation, Flex-Lag[®] Weld-On[™] Rubber Lagging offered an effective solution. Unlike their existing lagging, this weld-on rubber lagging was manufactured to fit right onto the pulley without having to be cut to fit. In addition, by installing Flex-Lag Weld-On Rubber Lagging, the wide gaps between strips were eliminated.

Flex-Lag Weld-On Rubber Lagging has made a big difference at this facility by decreasing issues with cleaner compatibility. Since the installation, the precleaner blades have not seen wear or needed replacement. Maintenance downtimes for retensioning and blade replacements have significantly diminished. With the average cost of downtime at an aggregates operation costing \$1000 an hour, this savings is crucial. The blade runs smoothly along the head pulley and the loud chattering noise has been completely eliminated with the newly installed lagging. Based on the success of his current lagging installation, the customer stated that he is definitely considering replacing his other slide-type lagging with the weld-on rubber lagging.
