Quarry Combats Carryback and Slippage with Flexco Cleaners and Pulley Lagging

HV Precleaner Flex-Lag® Ceramic Pulley Lagging

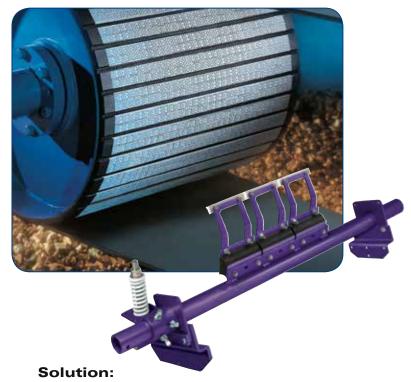
The proposal was to implement a trial Flexco HV precleaner mounted directly onto the conveyor's head drum on the feed conveyor system. These cleaners have a robust and compact construction and the low profile keeps them positioned below the flow of material. This increases tip life, improves cleaning efficiency, reduces downtime, and trimmed the additional costs attributed to tip change outs. It was also clear the existing rubber lagging needed to be replaced. Flex-Lag ceramic pulley lagging, also from Flexco, was installed to provide an increased coefficient of friction and eliminate the previous problems with belt slippage.

Material carryback was dramatically reduced, with between 85-90% reduction in material carryback. The days of having to throw sand and gravel on the pulley surface to provide an increased coefficient of friction and eliminate previous problems with belt slippage have gone. Flex-Lag's high-friction coefficient has eliminated this, delivering a performance close to double that of standard rubber lagging. Operators now spend less time on maintenance, leaving them clear to focus on the prime business, producing large quantities of quality product.
