Cement Manufacturer Turns to Flexco Fasteners to Reduce Downtime After Belt Failures

Cement

Raw Mill/Finished Mill and Crushing

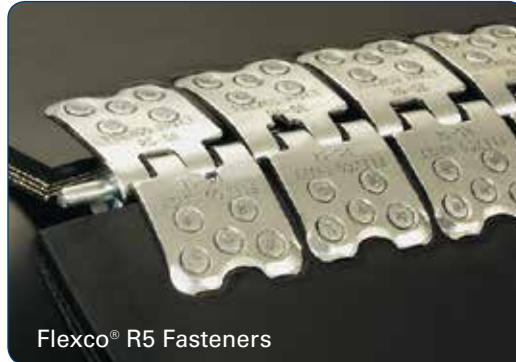
Flexco® R5 Fasteners

Since the cement plant had two different applications in one operation, a local distributor introduced them to two different mechanical fastening systems. The BR™ Rivet Solid Plate Fastening System was utilized for the raw mill/finished mill conveyor, where heavy sifting was a problem. The SR™ Rivet Hinged Fastening System was installed at the quarry site to best fit the small pulleys used in the conveying system that crushes large stones. Unlike during the process of vulcanisation, the installation of belt fasteners is not affected by the temperature, environmental conditions, and humidity levels, so the belts were able to be joined quickly and quality splices were achieved. These fastening solutions helped the maintenance team reduce downtime while waiting for the vulcanising contractors to arrive.
