# PT Max™ Belt Trainer Puts Steel Plant Back on Track

Conveyor belting leading to blast furnace at major steel plant in India

PT Max™ BeltTrainer

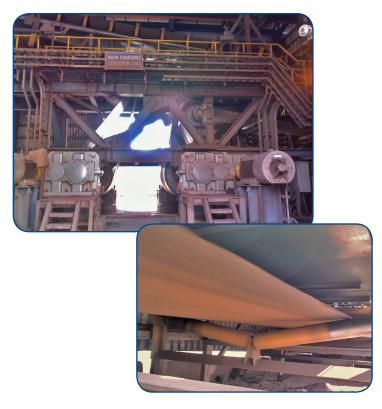
Belt carries iron ore, sinter, coal, dolemite, limestone, and quartzite.
Conveyor belt is 600 m long, 2000 mm wide, and the speed is 2.2 M/sec.

After close inspection, the decision to install belt trackers was made. The plant manager ordered six PT Max 2 m (84") Return and four PT Max 2 m (84") Top Side units.

After installation was complete, a trial run was executed and found a local belt tracker was hindering the performance of the PT Max. After adjusting the belt tracking, the senior manager at the blast furnace at the plant noticed the belt was running in the centre and was pleased with the results. Understanding the maintenance requirements of the system, they now check the return idlers, pivot and tilt action of the frame, guide idlers, and ensure that the sway is under control each month. The customer is happy with the overall performance of the product and feels that they have found the right fit for the future of the plant.
