PTEZ™ Belt Trainer Extends Clinker Belt Life at Cement Plant

Clinker Belt

PTEZ™ Belt Trainer

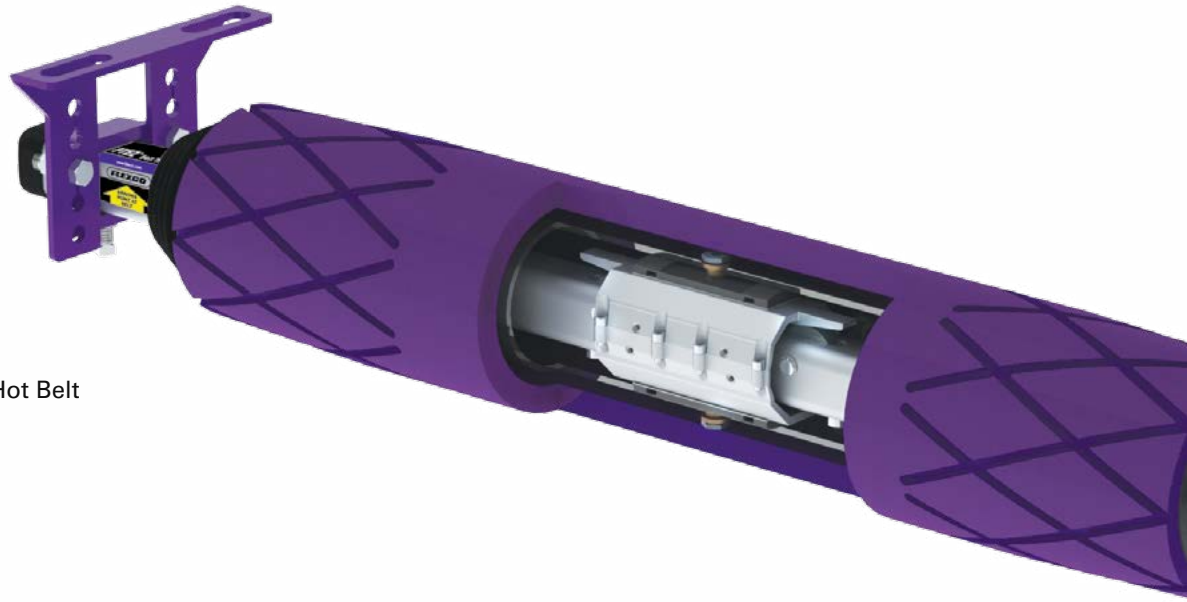
The PTEZ was installed on the clean side of the belt and results were immediate. Since the unit is sealed, its pivot and tilt technology is free to use two forces to track the belt without fear of freezing, allowing the edges to stay damage-free. The amount of splice repairs has decreased drastically and belt life has been extended greatly.

Because of the cement dust, the guide rollers that were being used to keep the belt out of the structure would freeze and cause excessive pressure on the belt, causing delamination and splice failures. Past belt trainers had also failed when the exposed center bearings would freeze due to the tough conditions. With this in mind, the team decided to bring in the PTEZ™ Belt Trainer from Flexco, which is ideal for use in both wet and dry conditions.
