## **80% Ceramic Dimple Flex-Lag® in Service for 20 Years, Still in Perfect Condition**

Flex-Lag® Ceramic Pulley Lagging

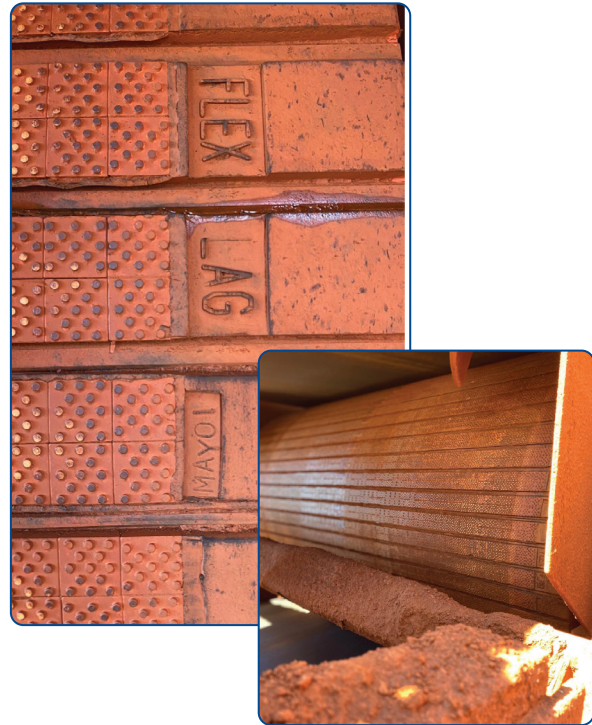
Although the main goal was to protect the pulley and combat spillage, the most astounding feature of the product was the increased cleaning efficiency of the primary cleaner. The near-perfect condition of the lagging after nearly 20 years in service has allowed the primary belt cleaner to have superior blade-to-belt contact.

The 80% coverage dimple ceramic Flex-Lag was installed in 2001. The lagging boasted the following benefits:

Another result that was unexpected from the site was the longevity of the lagging given the harsh iron ore material being conveyed. Installed in May 2001, this lagging has been proven to last nearly 20 years; not uncommon for Flex-Lag.
