Flexco Cleaners Tackle Extreme Carryback

Auto glass

Batch conveyor

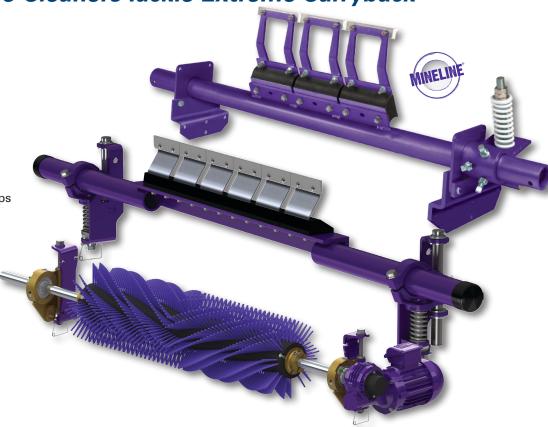
After assessing the situation, the Flexco team advised the maintenance team to remove all the polyurethane cleaners and replace them with carbide-tipped cleaners to avoid causing more static on the belt. A combination of the HV Precleaner, FMS Medium-Duty Secondary Cleaner with V-Tips, and Motorized Brush Cleaner was suggested.

An unconventional solution for driving the brush cleaner was also suggested when the options of a motor or head pulley were taken off the table. Instead, a hold roller, with the brush shaft slave driven off the hold down roller shaft, was utilized.

Results were immediate as a visual inspection revealed that carryback was reduced approximately 85% - a significant improvement. This also reduced the amount of time and money spent cleaning up the carryback. Additionally, the air supply to the vibrator was reduced to 10 psi, and is on a timer that runs for short periods of time at intervals, slashing compressor costs.

Finally, the unconventional hold down roller method suggested by Flexco and its distributor partner worked well. The customer was impressed with the fact that with hard work, a solution was found even when a product wasn't readily available to solve the problem.
