FGP Primary Cleaner

Out-Cleans and Outlasts Homemade Solution

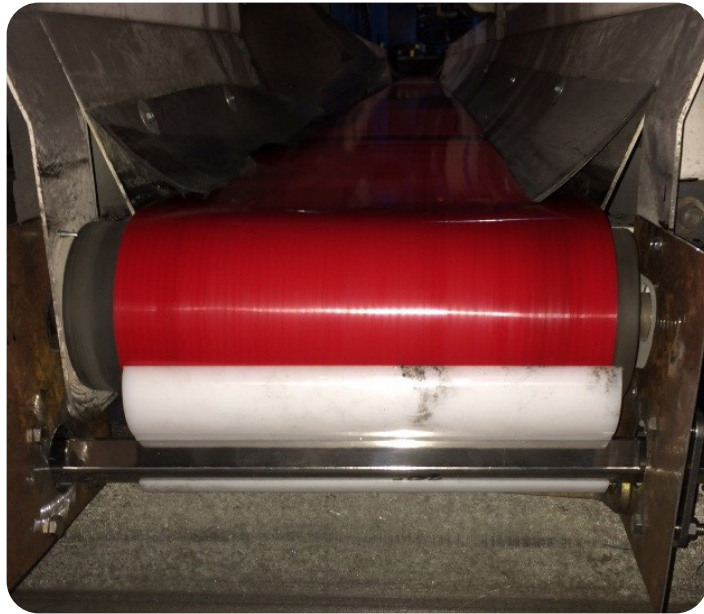
After inspection, the distributor advised the maintenance team at the plant to replace both the belt and the homemade cleaner. The PVC belt was replaced with a red urethane belt, which discouraged cuts from the bottles. The installation of the FGP Primary Cleaner with a spring tensioner allowed the cleaner to work with the belt without causing damage or belt wear.
