Application Profile

Flexco Load Zone Solutions Contain Dust At Aggregate Operation

Crusher Load Zone

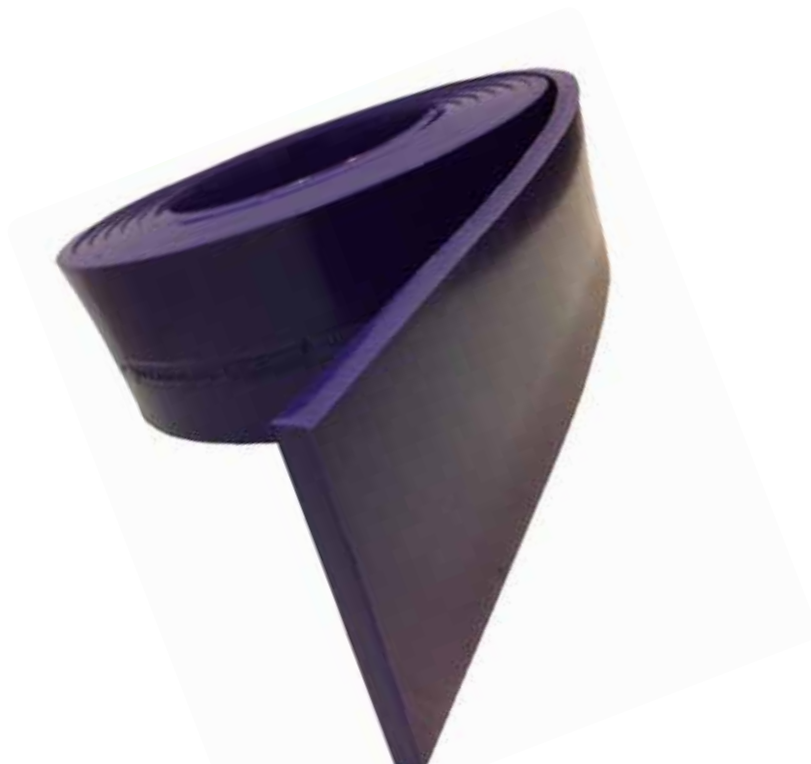
Belt width 1200mm, 3 ply belt, 600PIW rating handling minus 150mm material

Spillage has always been a problem for a Midwest aggregate operation and the solution they were using wasn't performing as efficiently as they had hoped. The maintenance team was using 12mm x 150mm rubber sheeting to try to seal under a transfer point that was hard to service, causing a housekeeping nightmare. The rubber had to be changed out every two weeks in an attempt to contain the material. This caused material buildup and increased time spent cleaning since one side of the conveyor was against the structure and couldn't be easily accessed.

When a Flexco representative gave the maintenance supervisor a half roll of Flexco Urethane Skirting, he was skeptical that there was a better, less expensive way to manage spillage. He installed it and waited for the results.

There was an immediate decrease in maintenance trips for clean up, and the skirting ran for more than two months without adjustment and spillage. Not having to replace the rubber sheeting is saving the plant approximately \$10,000 a year. The maintenance supervisor was so impressed that he is replacing all the 12mm rubber skirting to urethane throughout the plant, and he is treating other problem areas with the urethane solution.
