Iron Ore Mine Increases Roller Longevity with Flexco CoreTech™ Nylon Rollers

Crusher Feed Conveyor

CoreTech™ Nylon Rollers

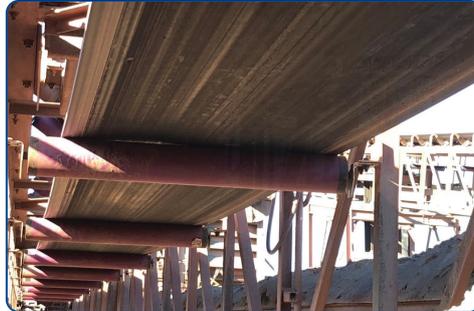
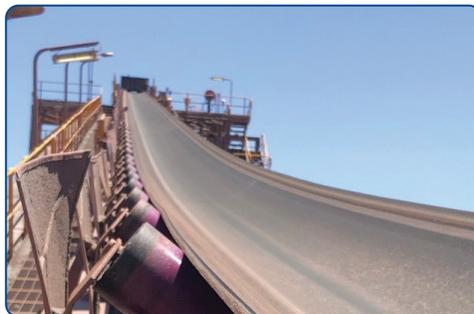
An Australian iron ore mine was constantly struggling with their steel rollers. The main issue was the short wear life of the product. As the roller casing was quickly wearing out, the bearings were also prematurely failing – mainly due to rapid wear of the bearing seal. This resulted in a “pizza cutter” effect, where the seized rollers would cause severe damage to the bottom cover of the conveyor belt.

The secondary issue, was that the ore product was constantly sticking to the roller shell. The build-up of product was causing severe tracking issues and contributing to further wear of the belt.

After assessing the challenges faced by the mine, Flexco and a local Flexco distributor encouraged the maintenance team to try Flexco CoreTech™ Rollers. The rollers are made from extruded nylon, so material easily sheds off the roller instead of creating a build-up. The rollers also feature a centrifugal seal with static ends, meaning even if the roller did fail, the bearing would not actually cut through the belt. The site agreed to a trial period on one conveyor.

Over each shutdown, the CoreTech rollers were monitored for wear and failures, with photos taken as a record. The site was so impressed with the results on the trial conveyor that they proceeded to switch out the steel rollers on another two conveyors with the CoreTech rollers as well. None of the rollers failed due to wear, and a full-site roller change-out is scheduled in the future.
