Flexco Polyurethane Skirting Outlasts Expectations

Coal Reclaimer Conveyor

Flexco Polyurethane Skirting

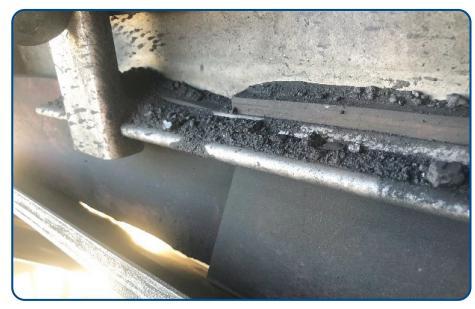
The coal port's existing skirting was failing to keep up with the speed of the belts and tonnages conveyed. The skirting was prone to rips and tears because of the poor quality of the polyurethane. After only a few weeks, the skirting began to wear extremely thin, eventually causing it to deflect from a 90° angle as shown below. Because of the defectiveness of the skirting, the site also had product build up on the idler frames, stringers, and conveyor pathway.

Existing Skirting

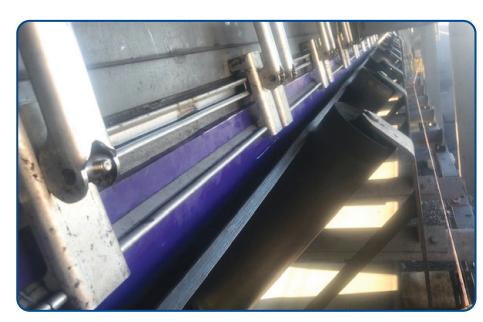
The port agreed to an 8-week trial of Flexco polyurethane skirting and recorded results for a period of 24 weeks. The initial goal was to ensure the skirting could outlast the previous product installed by a leading competitor. The current skirting would last no more than 8 weeks before beginning to tear and become ineffective.

Flexco Polyurethane Skirting on Week 1 of trial

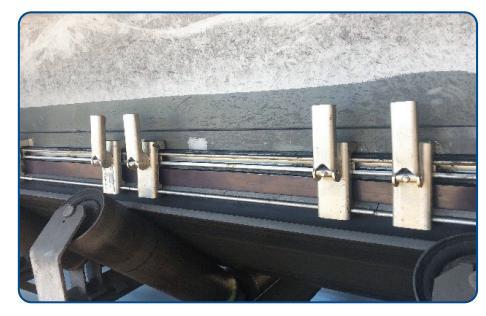
At the end of the initial trial period, the skirting showed no signs of wear – apart from the fading of the bright purple colour. The site decided to challenge the product, pushing the trial period out to 24 weeks. At the end of this period, the skirting still showed no signs of ripping, tearing, or deterioration. The skirting was also able to deliver on the initial goals set by site – all spillage was contained and the idler frames, stringers, and pathway were clear of build-up. This allowed the site to save money from not only having to replace the skirting far less often, but also on the labour needed to constantly clean around the conveyor to ensure the safety of all staff. The site also experienced less idler failures due to the lack of build-up.

Flexco Skirting after 24 weeks of service
