# **Optimised Cleaners Save Time and Money at Iron Ore Mine**

#### Application Conveying iron ore

25mm Tungsten Carbide Belt Cleaner Tips

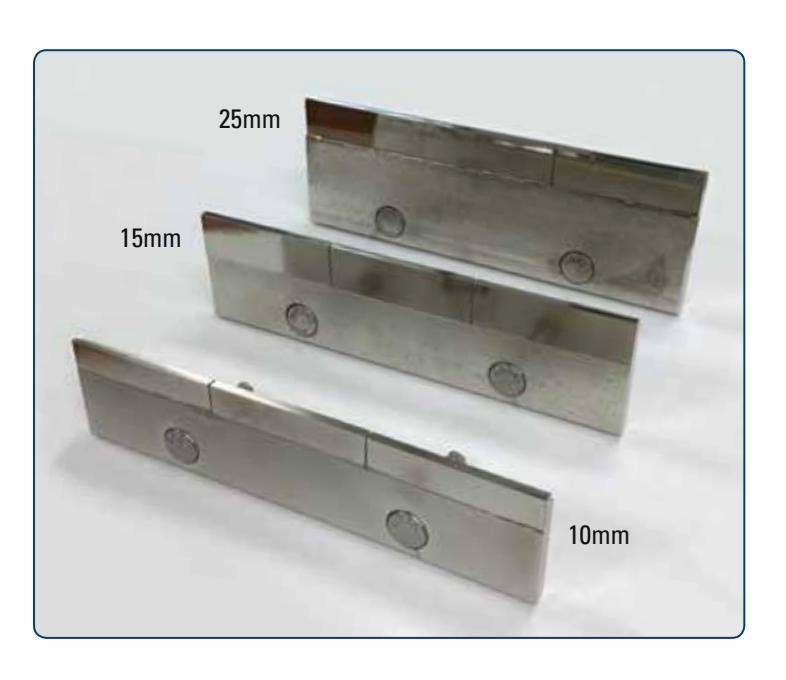
## **Conveyor Detail**

1500-1800mm Belt Width

The average tungsten carbide cleaner tip is 10-15mm long. This is an optimal length when mining resources such as metallurgical and thermal coal – but not for iron ore. Knowing this information and the need for an extended tip length in the market, Flexco set to work on creating a new tungsten tip to test in collaboration with this customer. Using the highest possible grade of tungsten carbide, Flexco created, manufactured, and began to test a 25mm secondary cleaner tip to complement its existing 25mm primary cleaner tip – which would eventually prove to last a full 20+ week shutdown period.
