Fish Processing Plant Solves Sanitation Problems With Help of Mechanical Belt Fasteners

Alligator® Plastic Rivet and Alligator® Staple fasteners

Reduce time spent cleaning belt conveyors, meet FDA requirements

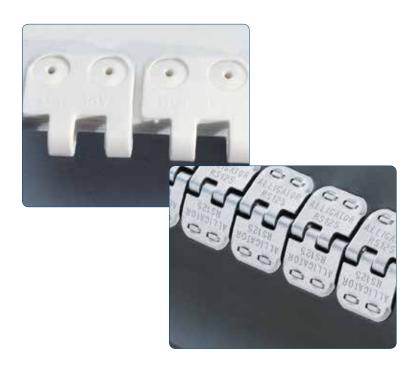
24" wide polyurethane, tabletop belts

After consulting with the local distributor, the plant superintendent decided to try Alligator® fasteners instead of endless spiicing the belts. With hinged fasteners, the maintenance crew could simply take out the hinge pin and pull the belts apart to sanitize both the top and bottom of

the belt. This could not be done with the endless belts, making them extremely difficult to clean. Alligator Plastic Rivet fasteners were used on the belts that came into direct contact with the tuna, while Alligator Ready-Set* Staple fasteners were used on belts that carried trays and waste disposal belts.
