PT SMART™ SAVES CEMENT PLANT \$250K**Industry**

PT Smart™ Belt Trainer

Fix a mistracking belt

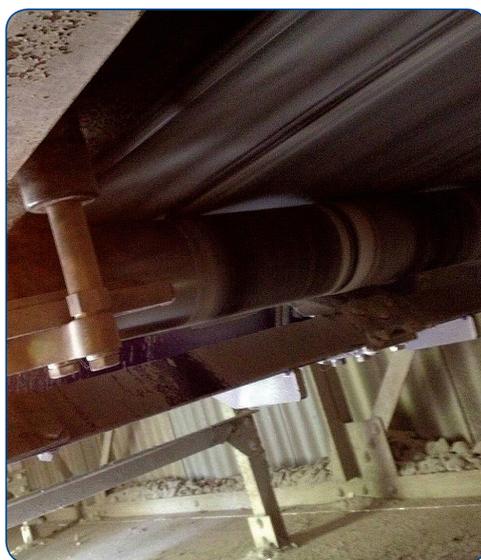
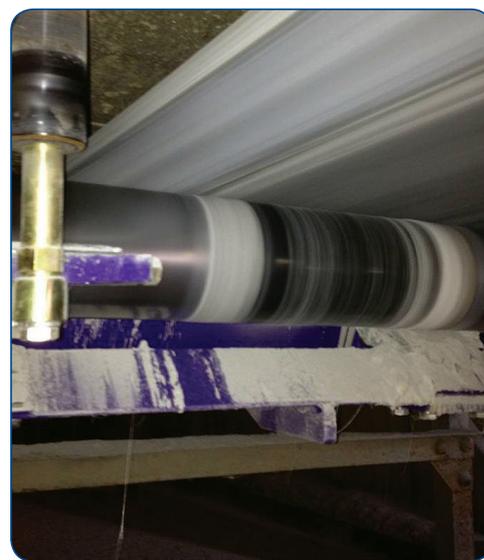
The crew at an East Coast cement plant had been struggling with an ongoing, chronic problem on their 914 m (3000 ft.) belt conveyor – mistracking. It was so prevalent that the belt had even cut through the structure, damaging the support legs of the conveyor frame. They were told time and time again that it was a problem with their belt.

The crew considered purchasing a new belt, which would have cost them approximately \$250,000. However, they weren't interested in waiting the 3-4 month lead time for the belt or dealing with the three-day downtime of putting a whole new belt on the conveyor. Instead, they asked representatives from their local distributor and Flexco to look at the system. It was determined that "cupping" was the issue with the belt and that installing trainers high enough onto the belt would flatten it and provide traction. The PT Smart™ Belt Trainer was chosen because of its success on medium-duty belts. A total of 14 trainers were installed.

The patented "pivot and tilt" design of the PT Smart immediately reacted and compensated for the belt mistracking, ensuring that the belt stayed away from the structure and the material stayed on the belt. After more than a year, the system was still going strong. The perfectly-good belt was retained, at a savings of \$250K, and the crew was thrilled with the performance of the PT Smart.
