Airport's Baggage Scanning System Experiences Fewer Delays with Flexco Narrow Gap Transfer Plate

X-ray conveyor/baggage inspection

Flexco Narrow Gap
Segmented Transfer Plate

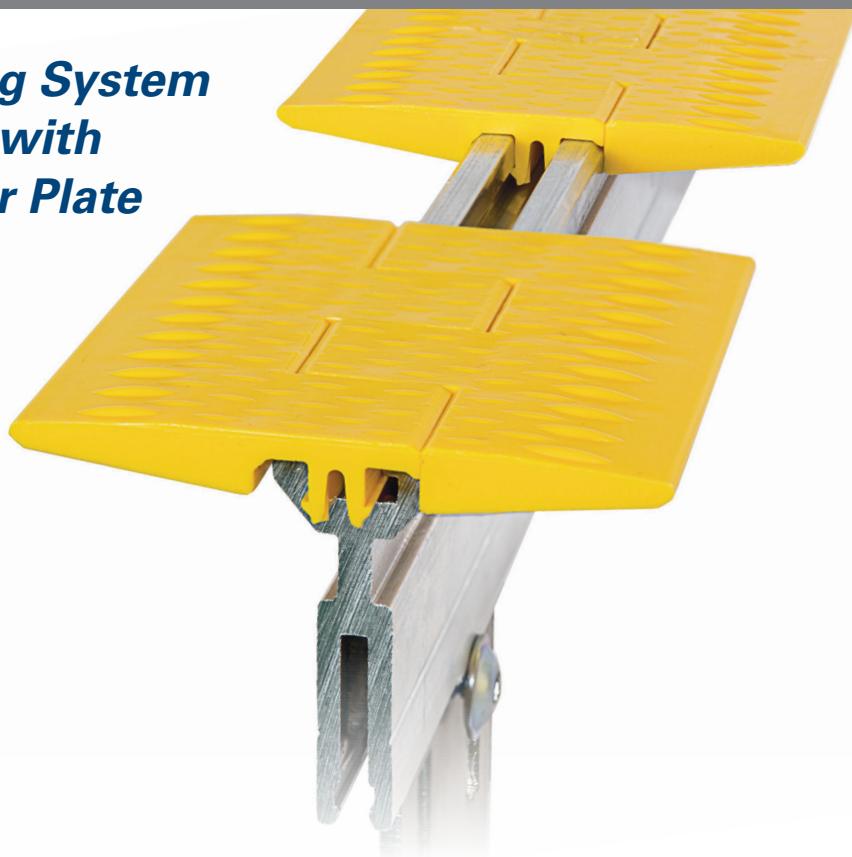
The use of a Segmented Transfer Plate was suggested in order to minimize these risks by allowing a smooth flow of baggage, with the added benefit of protecting the equipment. The Narrow Gap version of the plates was installed between these conveyors to provide smooth movement through the small gaps from 1.5" to 3" (38 mm to 75 mm) in width. During installation, a combination of paired special brackets, combined with plastic segments, lock together inside the support bar to create the span required for this application. This system is unique to X-Ray scanning equipment; the equipment tolerances and tight component packaging require solutions that can blend with the original design and be easily serviced.

Installing Narrow Gap Segmented Transfer Plates from Flexco in these areas resulted in a reduction of unscheduled downtime and increased system effectiveness. The lines may be long in security at this airport, but it certainly isn't because of the x-ray machines, which are now moving customer bags safely and smoothly with fewer stoppages.
