## **PT Max™ Belt Trainer Puts Steel Plant Back on Track**

Conveyor belting leading to blast furnace at major steel plant in India

# *Application Profile*

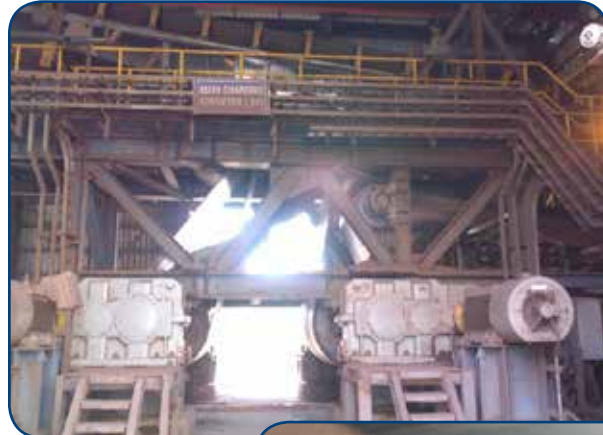
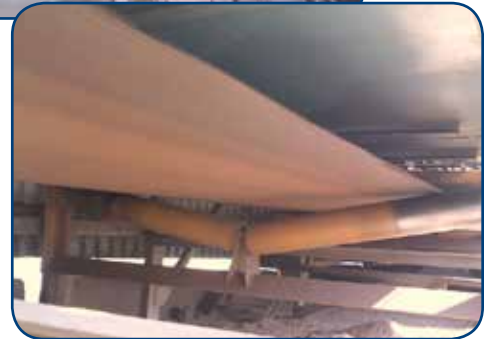
The largest integrated private steel manufacturer in India in terms of installed capacity had a problem with belts mistracking, causing spillage and belt damage. The main concern was with the BFC3 belt carrying iron ore, sinter, coal, dolomite, limestone and quartzite from bins to the blast furnace. The plant's manager requested a solution that not only increases the life of the belt but also reduces the spillage.

After close inspection, the decision to install belt trackers was made. The plant manager ordered six PT Max 84" Return and four PT Max 84" Top Side units.

After installation was complete, a trial run was executed and found a local belt tracker was hindering the performance of the PT Max. After adjusting the belt tracking, the senior manager at the blast furnace at the plant noticed the belt was running in the centre and was pleased with the results. Understanding the maintenance requirements of the system, they now check the return idlers, pivot and tilt action of the frame, guide idlers, and ensure that the sway is under control each month. The customer is happy with the overall performance of the product and feels that they have found the right fit for the future of the plant.
