## Quarry Combats Carryback and Slippage with Flexco Cleaners and Pulley Lagging

HV Precleaner  
Flex-Lag® Ceramic Pulley Lagging

Reduce carryback and slippage, especially in cold and wet weather.

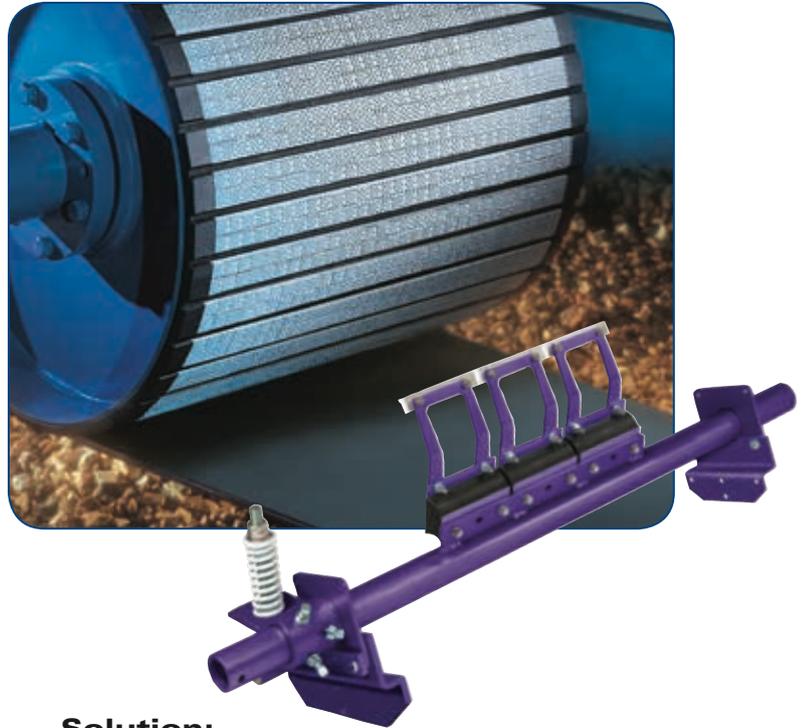
Significant amounts of material were being carried back along the underside of the conveyors. This would accumulate and foul the conveyors return rollers, structure, and the ground underneath. In turn, this meant costly and time-consuming clean-ups for the plant's operators.

Added to the problems were the conditions coming into play when the weather was cold and wet. The main belts were prone to regular slippage, because of inadequate drum lagging materials. The result was predictable; less production capacity and spillage at transfer points.

The proposal was to implement a trial Flexco HV precleaner mounted directly onto the conveyor's head drum on the feed conveyor system. These cleaners have a robust and compact construction and the low profile keeps them positioned below the flow of material. This increases tip life, improves cleaning efficiency, reduces downtime, and trimmed the additional costs attributed to tip change outs. It was also clear the existing rubber lagging needed to be replaced. Flex-Lag ceramic pulley lagging, also from Flexco, was installed to provide an increased coefficient of friction and eliminate the previous problems with belt slippage.

Material carryback was dramatically reduced, with between 85-90% reduction in material carryback. The days of having to throw sand and gravel on the pulley surface to provide an increased coefficient of friction and eliminate previous problems with belt slippage have gone. Flex-Lag's high-friction coefficient has eliminated this, delivering a performance close to double that of standard rubber lagging. Operators now spend less time on maintenance, leaving them clear to focus on the prime business, producing large quantities of quality product.
