Application Profile

PT SMART™ SAVES CEMENT PLANT \$250K

PT Smart™ Belt Trainer

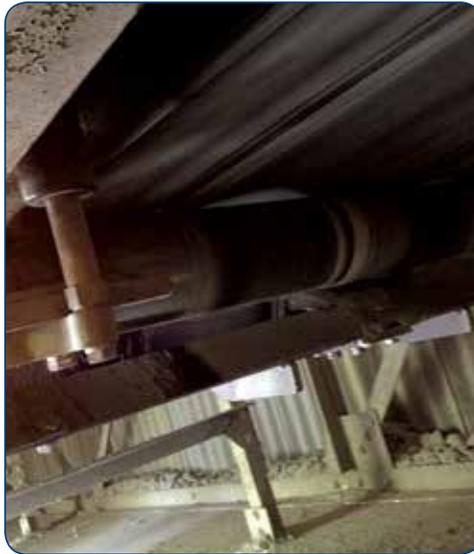
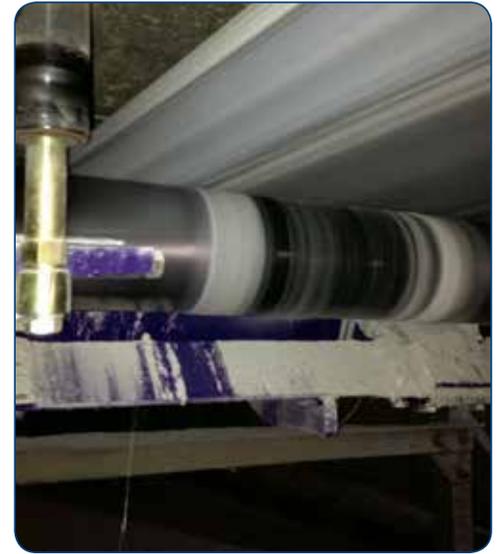
The crew at an East Coast cement plant had been struggling with an ongoing, chronic problem on their 3000 ft. belt conveyor – mistracking. It was so prevalent that the belt had even cut through the structure, damaging the support legs of the conveyor frame. They were told time and time again that it was a problem with their belt.

The crew considered purchasing a new belt, which would have cost them approximately \$250,000. However, they weren't interested in waiting the 3-4 month lead time for the belt or dealing with the three-day downtime of putting a whole new belt on the conveyor. Instead, they asked representatives from their local distributor and Flexco to look at the system. It was determined that "cupping" was the issue with the belt and that installing trainers high enough onto the belt would flatten it and provide traction. The PT Smart™ Belt Trainer was chosen because of its success on medium-duty belts. A total of 14 trainers were installed.

The patented "pivot and tilt" design of the PT Smart immediately reacted and compensated for the belt mistracking, ensuring that the belt stayed away from the structure and the material stayed on the belt. After more than a year, the system was still going strong. The perfectly-good belt was retained, at a savings of \$250K, and the crew was thrilled with the performance of the PT Smart.
