Gravel Plant Learns the Importance of Calculating Transition Distances in the Load Zone

Load Zone Containment

DRX™ 3000 Impact Bed
Enclosed skirting

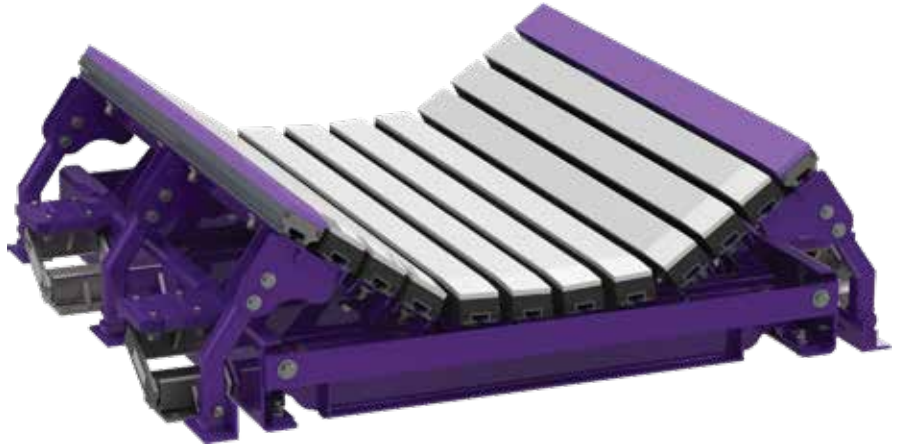
Immediately upon his arrival, the Flexco representative noticed that transition distance and

belt elevation were not considered, and the top of the pulley was higher than the idler center cans. This created a partial trough transition, which can fold the belt up faster than a full trough transition if done correctly. In this case, it was not executed properly, which caused the belt to ride out of the trough when the belt was empty. When the belt is loaded with material, this can cause the belt to drop below the sealing section, leaving a large gap between the skirt wall/sealing material and the belt. No solid seal resulted in no material containment.

To fix this, the team was instructed to simply lower the tail pulley to be the exact same height as the top of the troughing center idler can. The DRX 3000 and Enclosed Skirting System were then adjusted, and the dust and spillage problems were eliminated thanks to a solid bed and effective seal.
