PT Max™ Combats Belt Mistracking, Belt Damage, and Spillage

Iron Ore

Primary Crusher

PT Max™ Belt Trainer

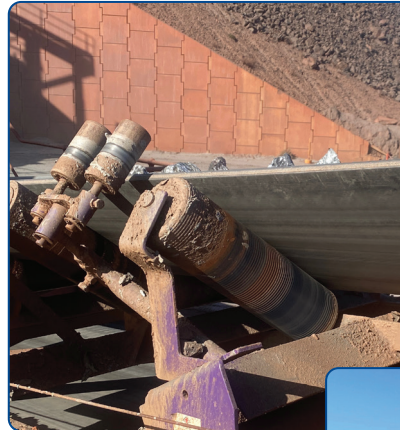
*PT Max™ Belt Tracker
from Flexco*

After working closely with the mine, Flexco Territory Manager, Jayden Baker recommended the PT Max™ Belt Trainer. Unlike the previous product, the PT Max features patented “pivot and tilt” technology. This technology allows the trainer to compensate immediately to belt misalignment, with the goal of the belt staying away from the structure and keeping the material on the belt.

With the PT Max's ability to pivot and tilt, the belt began to run true immediately. The site changed out all the trackers on the belt, replacing each with a PT Max. This action removed all previous issues – including belt damage and spillage. By doing so, the site was able to save thousands of dollars in unscheduled downtime and belt repair.

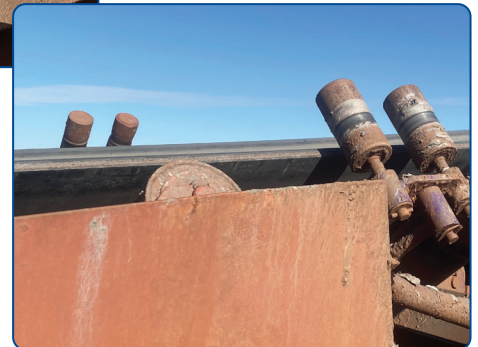
An Australian Iron Ore site had stationary trackers installed that did not move with the belt, resulting in a multitude of problems. Due to the trackers being completely stationary, the guide rollers eventually began to wear into the belt, causing severe damage. This resulted in not only belt damage, but the rapid change out of the guide rollers and thousands of dollars spent on parts and labour.

On top of this, the trackers were completely ineffective, which led to a myriad of other issues along the conveyor line. Most of these issues were surrounding the amount of product falling off the belt. This spillage would pile up underneath and beside the conveyor and would require several workers to manually shovel away the excess product, creating safety concerns for the mine.
