## **Flexco Dual Seal Polyurethane Skirting Reduces Clean-Up, Protects Belt**

Flexco Dual Seal Polyurethane Skirting

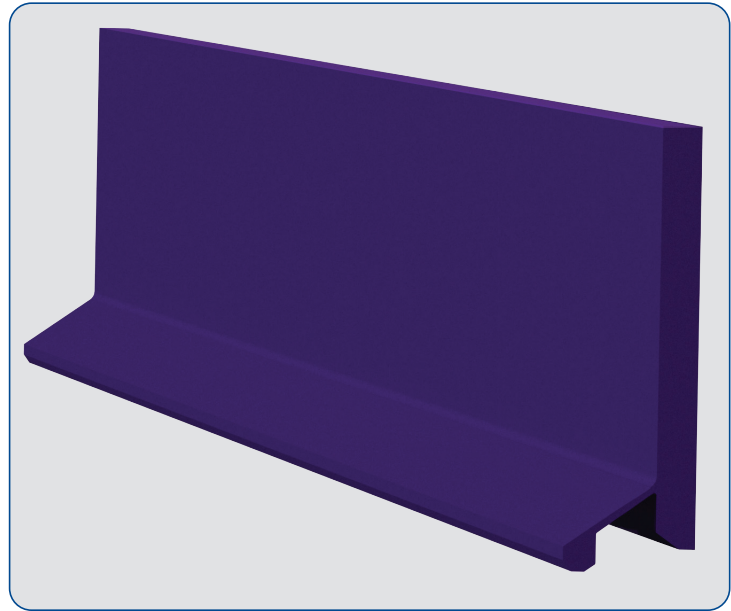
- 1400 mm wide, 15 mm thick, 50 meter long high angle conveyor belt

During a routine visit, Flexco's regional sales representative and the local distributor were alerted to the supervisor's pain point. After inspecting the area, they recommended the installation of Flexco Dual-Seal Polyurethane Skirting in the critical conveyor area. The easy-to-adjust design makes on-site modifications safer and simple for workers. A secondary seal provides a floating contact area behind the main slab to prevent spillage.

Upon installation, the success of the Flexco Dual Seal Polyurethane Skirting was immediate. The two contact points that run the entire length of the skirtboard not only prevented material spillage, but also significantly decreased dust emissions, leading to a cleaner overall plant. The Dual Seal Polyurethane has also already lasted three times longer than the previous skirting. The manpower that previously cleaned the spillage has been reassigned to other areas.
