Alligator® Spiral Lace Improves Cleaning Efficiency At Bakery

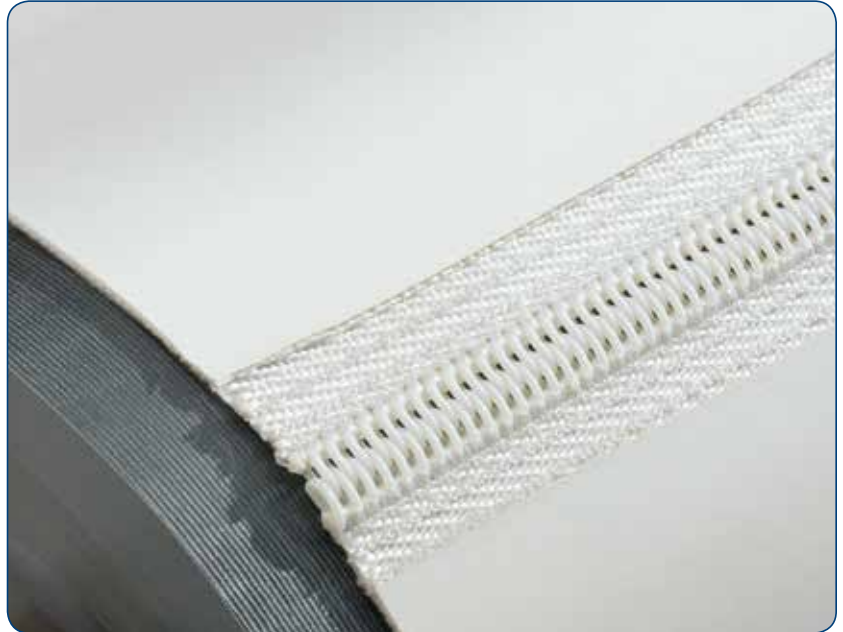
Conveyor Detail

Polyurethane belting

The Alligator® Spiral Lace system seemed like the perfect answer to the challenges faced by this bakery. Ideal for applications that have small pulleys, the Alligator Spiral Lace System features non-metallic, low-profile fasteners. Made from FDA-compliant material, the removable hinge-pin design also allows for easy cleaning of belts.

Finally, the spiral loop is a continuous monofilament across the entire splice width, eliminating certain product contamination concerns present with segmented fasteners.
