## ***Flexco's Enclosed Skirting System Saves 300 Hours of Annual Lost Production at a Cement Plant***

Cement Plant

Enclosed Skirting System

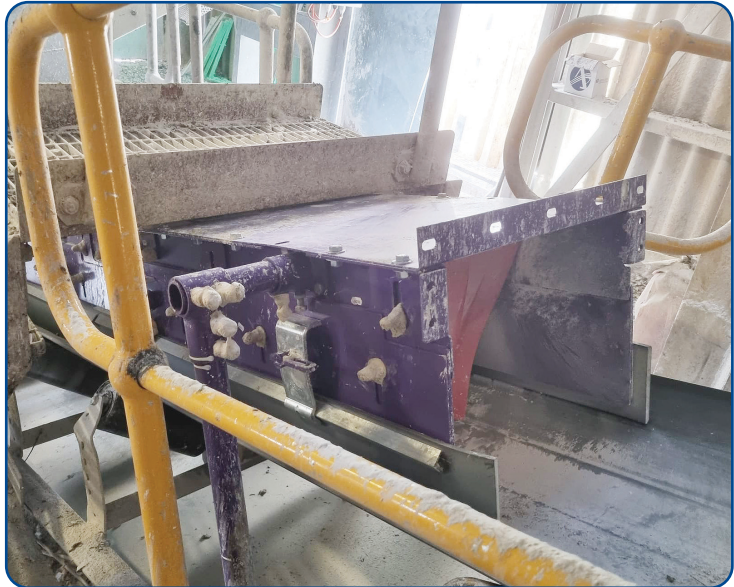
One of Australia's largest producers of clinker and limestone was experiencing excess dust at their transfer chute. When the conveyed material hits the belt from the transfer chute, it causes the dust to rebound off the belt and into the atmosphere, generating significant quantities of respirable dust and spillage in the walkways that put their staff's safety at risk when conducting tasks at the conveyor and surrounding area. The site was currently using a rubber curtain at the end of the transfer chute, but it was unable to sufficiently contain or suppress the airborne dust. As a result, to minimise safety hazards, the site was left with no choice but to barricade the area and impose no entry while in operation.

The cement plant called an authorised Flexco distributor to assess the area and recommend suitable solutions for dust and spillage containment. The distributor and their Flexco Territory Manager assessed the area and proposed a 2.4-metre-long enclosed skirting system custom-engineered to fit the existing chute and the 800mm wide conveyor belt. The enclosed skirting system included custom wear liners to provide increased skirt liner life, dust curtains to control the airflow and keep dust levels low, and Flexco's proprietary polyurethane skirting offering 3-4 times more wear life than rubber skirting.

The site saw an immediate reduction in dust and spillage in the walkways once the enclosed skirting system was installed. Nearly all the airborne dust has been eliminated to the extent that the area has been deemed safe for workers to enter without a dusk mask while in operation. Additionally, minimal maintenance and cleaning duties are required. Previously, the site spent \$5,000 per month on external contractors and a vacuum truck to clean the area. This process would not only cost the site time, labour resources and money, but it would halt production for 25 hours per month. This meant the site was losing \$60,000 on external maintenance costs and 300 hours of lost production per year. Flexco's custom enclosed skirting system has eliminated these costs for the operation, with no maintenance or clean-up required since it has been installed 3 months ago. With the substantial improvements in safety, maintenance requirements, and dust containment, the cement plant plans to install an additional custom-enclosed skirting system for another conveyor.
