PT SMART™ SAVES CEMENT PLANT \$250K

PT Smart™ Belt Trainer

Fix a mistracking belt

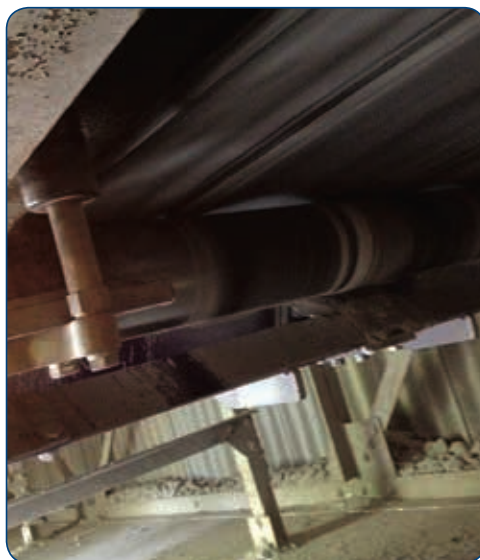
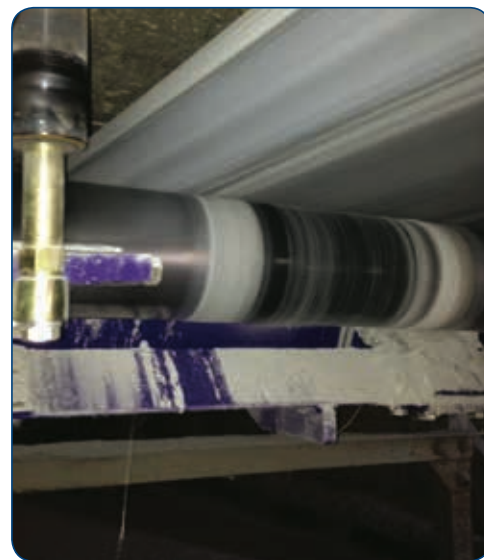
The crew at an East Coast cement plant had been struggling with an ongoing, chronic problem on their 914 m (3000 ft.) belt conveyor – mistracking. It was so prevalent that the belt had even cut through the structure, damaging the support legs of the conveyor frame. They were told time and time again that it was a problem with their belt.

The crew considered purchasing a new belt, which would have cost them approximately \$250,000. However, they weren't interested in waiting the 3-4 month lead time for the belt or dealing with the three-day downtime of putting a whole new belt on the conveyor. Instead, they asked representatives from their local distributor and Flexco to look at the system. It was determined that "cupping" was the issue with the belt and that installing trainers high enough onto the belt would flatten it and provide traction. The PT Smart™ Belt Trainer was chosen because of its success on medium-duty belts. A total of 14 trainers were installed.

The patented "pivot and tilt" design of the PT Smart immediately reacted and compensated for the belt mistracking, ensuring that the belt stayed away from the structure and the material stayed on the belt. After more than a year, the system was still going strong. The perfectly-good belt was retained, at a savings of \$250K, and the crew was thrilled with the performance of the PT Smart.
