# **Application Profile**

# DRX<sup>™</sup> Impact Bed Increases Belt Life, Cuts Maintenance Time

Underground Mining

DRX<sup>™</sup> 1500 Impact Bed

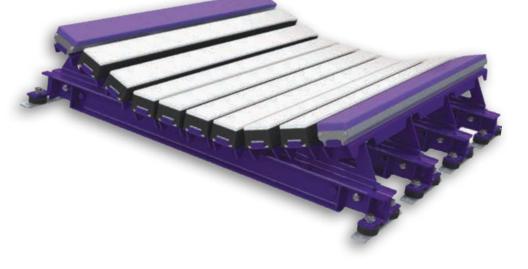
When specifying the conveyor system for a gold and copper mining operation, the application and materials being conveyed were not considered. The original equipment manufacturer installed an undersized slider bed and idlers that were being destroyed by the oversized load being dropped.

The maintenance team realized a larger bed was needed to prolong the life of the belt and decrease the weekly downtime that was being spent repairing the belt. A Flexco DRX 1500 Impact Bed was installed.

After several weeks, no belt damage has been reported in the load zone area, meaning less maintenance. In the future, the operation will be considering the application when specifying conveyor components.
