## Flexco Load Zone Solutions Contain Dust at Cement Plant

1120 ft., 24" 3 ply 300 XL750 Hot Belt

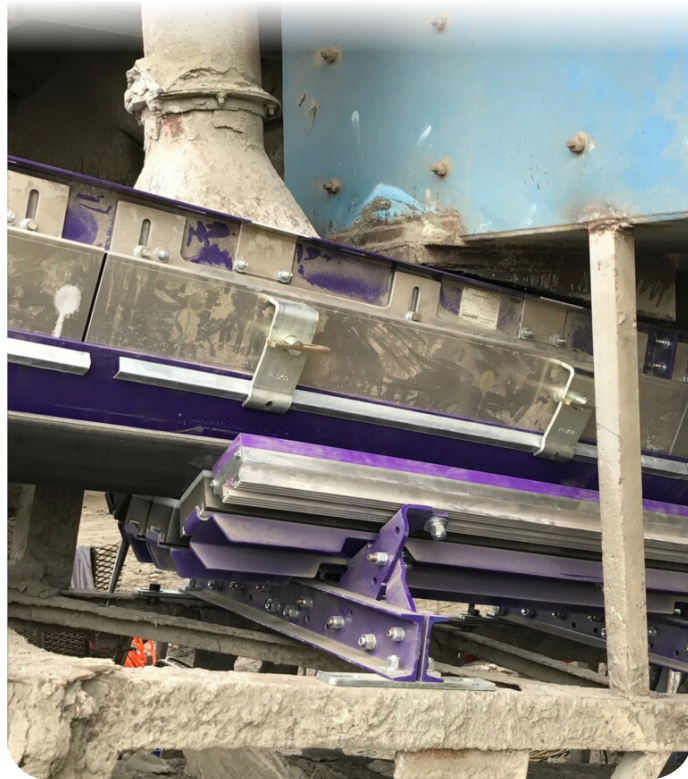
A cement plant located in the Midwest had serious spillage build up at the load zone, which presented several problems. The first was mistracking due to the spillage, which damaged the belt and halted production. Next, the spillage also caused housekeeping issues that were often the focus of MSHA warnings. Finally, the respirable allowable dust levels were exceeded, which forced workers to wear masks for their safety. Their current system was not making maintenance easy, with disassembly of the entire unit a necessity, so they needed a new solution.

After a visit from a Flexco sales rep and a product trailer, the plant manager was so impressed with the unique solutions available that he decided to try out a few. Flexco suggested placing Impact Beds, Urethane Skirting, and an Enclosed Skirt System in the load zone.

The Impact Beds provided a solid surface for dust sealing at the load zone, while the Skirt System focused on containment, with adjustable wear plates that are easily replaceable when the time comes. The Urethane Skirting, used in place of rubber, also provided better wear life. The total system has reduced cleanup and damage to the belt, which pleased the manager so much that three similar projects are scheduled for completion.
