## **PTEZ™ HD Belt Trainer Solves Mistracking Problem in Tight Quarters at Midwest Mining Operation**

PTEZ™ HD Belt Trainer

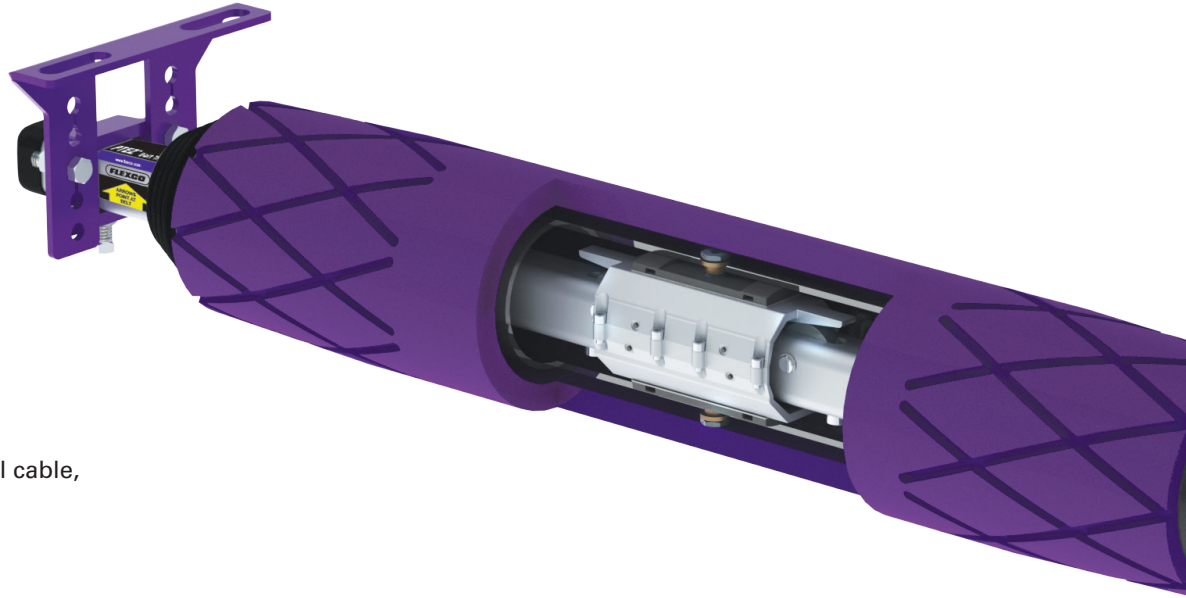
Not only was the PTEZ a good fit in the tight space because of its small footprint; it also performed well. The PTEZ HD was more effective than the trainer it replaced, and did not damage the ends of the belt like other trainers had done. The PTEZ HD is also rugged enough to handle the abrasive application, featuring urethane lagging for exceptional wear life over conventional rubber lagged trainers.

This operation experienced previous success with nine Flexco PT Max™ Belt Trainers located throughout the facility. This positive experience led the maintenance supervisor to contact Flexco for solutions to this problem. After evaluating the application, Flexco recommended the PTEZ™ HD Belt Trainer. Developed for return-side mistracking, the PTEZ HD is designed to handle tough mining conditions, utilizing pivot-and-tilt technology to track the belt without the use of sensor rollers.
